CHARACTERIZATION OF ION IMPLANTED AND  
LASER PROCESSED WEAR SURFACES

Final Report: Contract No. N00014-85-K-0066

Sara A. Dillich  
Department of Mechanical Engineering  
Worcester Polytechnic Institute  
Worcester, Massachusetts 01609

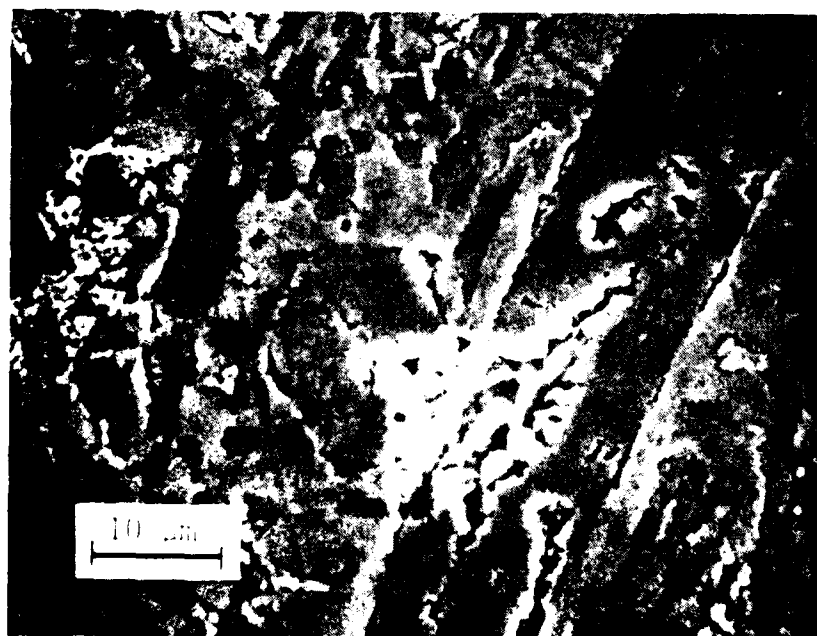
Figure 1. Cavitation erosion tested, implanted tooth 3  
 sample after 1 hour of cavitation and after  
 25 hours of cavitation.

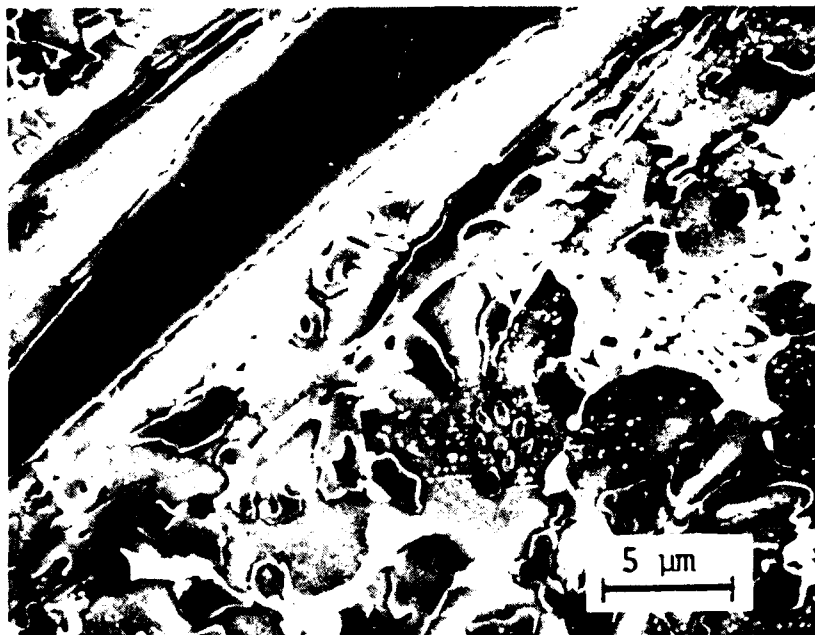
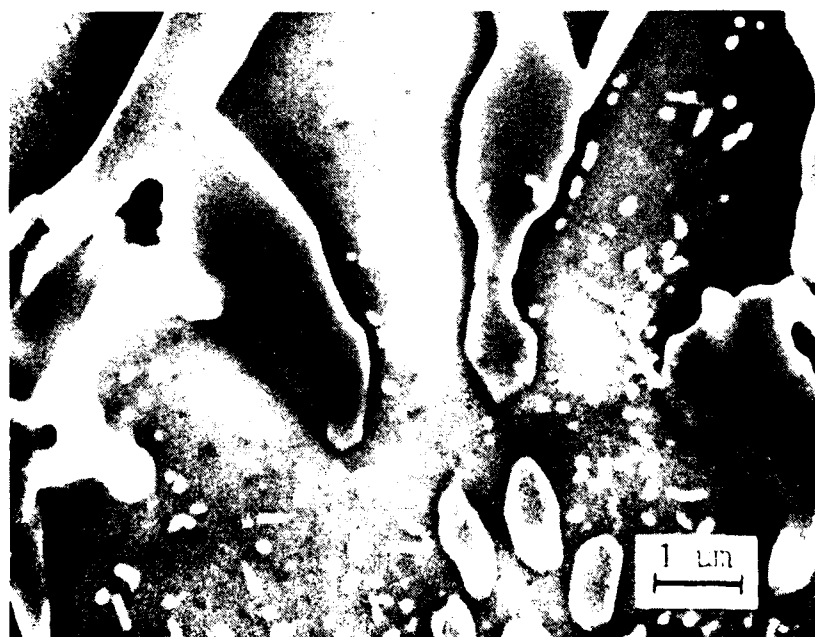
Figure 10. SEM micrographs of a nonimplanted foil. Several distinct carbide morphologies could be distinguished in the alloy: large dark lath or block shaped carbide, a light "script" phase, and smaller light and dark elliptically shaped carbides dispersed between the larger carbides.

The foils were thinned by one-sided electropolishing, at 50 °C, in a solution of 15% HNO<sub>3</sub> in Methanol. Plastic "dummy" foils protected the surface of interest (i.e., the implanted surface or, in the case of non-implanted foils, the as-polished surface) from the electrolyte during thinning. Thinned regions on the foils were examined in a 100 kV electron microscope (JEOL 100C STEM). Transmission of electrons at this energy is limited to regions of  $\approx 150$  nm maximum thickness i.e., corresponding to the range of ion penetration on the implanted surfaces (7). Microstructural features of the nonimplanted material were examined to establish a reference for the implanted surfaces. SEM micrographs of a nonimplanted foil, are shown in Fig. 10. Several distinct carbide morphologies can be distinguished in the alloy: large dark lath or block shaped carbides, a light "script" phase, and smaller light and dark elliptically shaped carbides dispersed between the larger carbides. EDX analysis revealed the metal components of the carbides to be Cr-Co-W solutions, with the lighter appearing carbides having higher W concentrations than the darker. Exact stoichiometries of these carbides have yet to be determined.

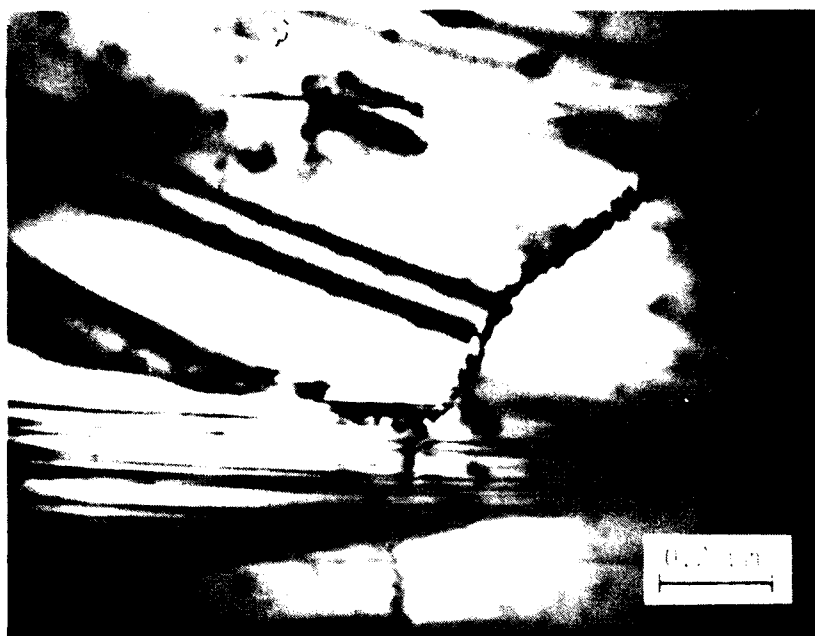
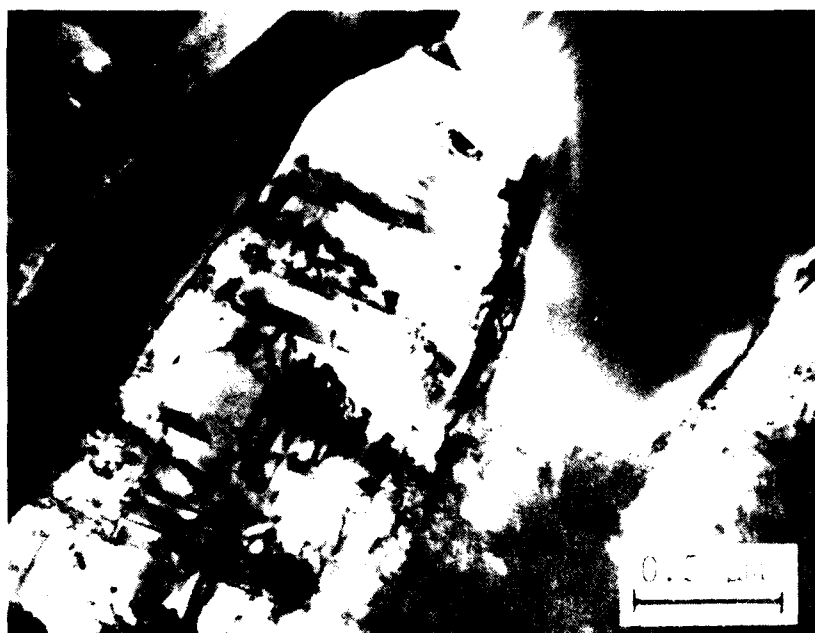
Figure 11. Brightfield micrographs of nonimplanted foils. The matrix phase was characterized by networks of planar defects running through the grains (top). Dislocation tangles were seen, infrequently, in combination with the faults or concentrated at the grain boundaries (bottom).

Bright field TEM micrographs and Selected Area Diffraction (SAD) patterns from nonimplanted foils are shown in Figs. (11-13). The matrix phase of the alloy is characterized by networks of planar defects, predominantly stacking faults, running through the grains, extending occasionally from one matrix grain to another (Fig. 11). Dislocation tangles could be found, infrequently, in combination with the stacking faults or concentrated at grain boundaries (Fig. 11). At present, faults and dislocations in the alloy have not been fully characterized. Single crystal diffraction

produce changes in the crystallinity of the surface, a striking increase in the fault density was observed (Compare Figs. 19 & 20 with Figs. 11 & 12).

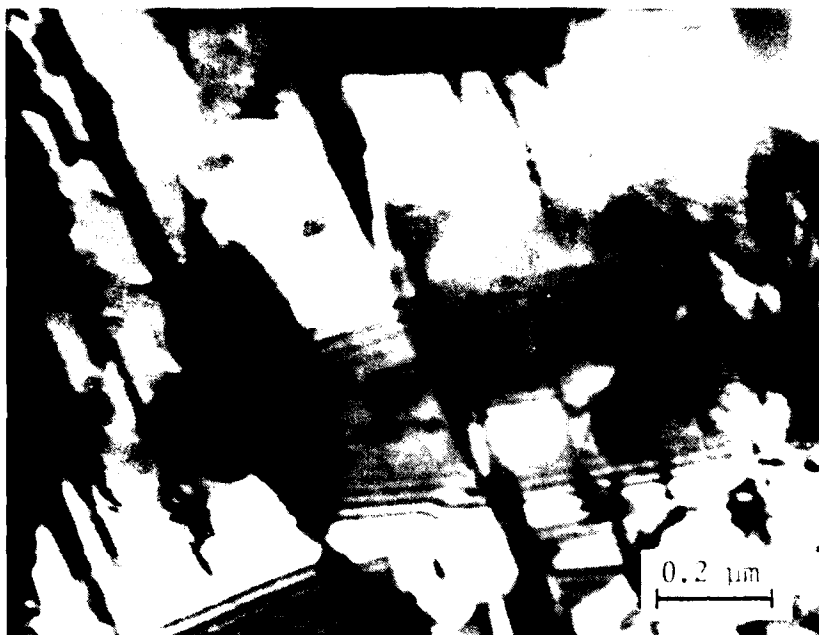
Figure 12. Brightfield micrograph of the matrix phase in a nonimplanted foil and the corresponding SAD pattern (110 zone, fcc).

patterns from the cobalt-rich matrix phase indicated only the presence of the metastable fcc phase (e.g., Fig. 12), suggesting that cold working during the polishing process was not sufficiently severe to produce the martensitic fcc-hcp transformation at the surface. The large carbides appeared semi-opaque and virtually defect free. SAD patterns from these carbides (Fig. 13) were typical of those produced by single crystal complex carbides.

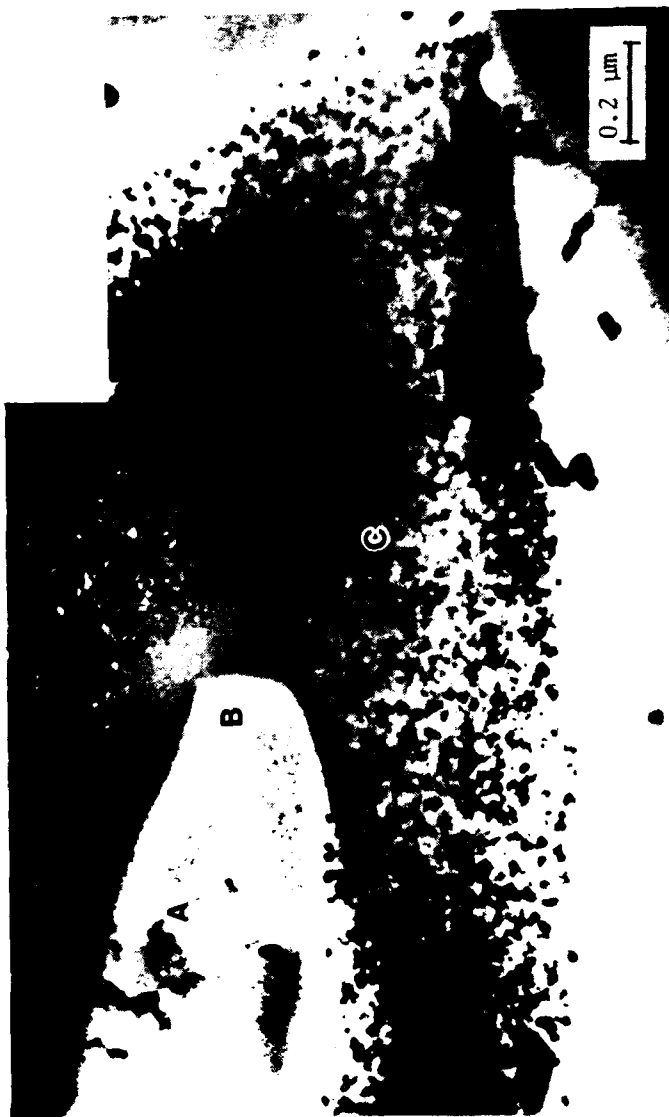
Figure 18. Brightfield micrograph of the Ti implanted foil and EDX spectra from a) matrix, b) matrix material bordering the carbide and c) carbide. The matrix appeared to have a lower surface concentration of Ti than the carbide or bordering matrix material.

The effects of Ti implantation on the alloy microstructure are shown in Figs. 15-18. Implantation produced an amorphous matrix phase, as evidenced by the diffuse rings in the SAD patterns from this phase, and by the absence of defects i.e., dislocations and planar faults (Fig. 15). Similarly, the carbides were transformed from monolithic single crystals to fine-grained polycrystals (Figs. 16 & 17), with diffraction spots forming ring patterns (Fig. 17). Partial amorphization of the carbide surfaces is suggested by the diffuse nature of the rings. The carbides were outlined by borders of light contrast, matrix material which, on close inspection, appeared carbide depleted. EDX analysis of the border region shown in Fig. 18 indicated higher Ti concentrations in the carbides and bordering matrix than for the neighboring, darker contrast matrix material. Preferential carburization (i.e., the formation of a Ti + C enriched surface layer (7)) at or near the carbides during implantation is a possible explanation of this result.

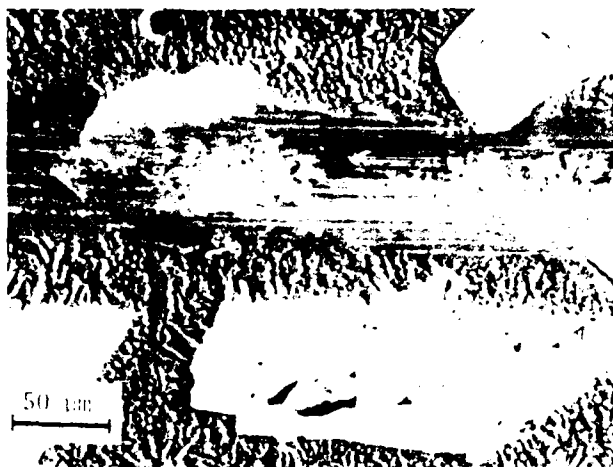
Fig. 3 - Wear track on WC/Ti disk 80-21 after Ti implantation, 20 pass region

80-21, shown in Fig. 3, illustrating the plowing damage deformation to the matrix phase. The Ti implanted TiC/Ti disk, 80-5, was the least degraded by wear. Although considerable debris was generated and deposited on the carbides, the matrix phase of this surface appeared undamaged (Fig. 4, left). The carbides in the implanted disk showed more damage after wear than in the nonimplanted disk. As seen in the DIC micrograph in Fig. 4 (right), sliding produced grooves in the TiC particles. Even more severe damage to the carbides was observed on the other implanted disks. Occasionally, carbide particles in the implanted tracks appeared to have been fractured and fragmented during testing, permitting fine carbide debris to be distributed in some of the tracks (Fig. 3).
